James Webb Space Telescope (JWST) Detector Degradation Failure Review Board (DD-FRB)

Executive Summary: Root Cause Determination

29 April 2011

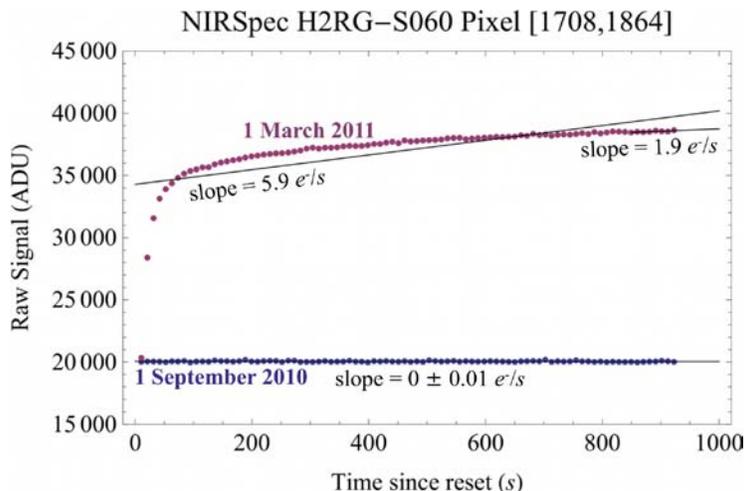
Instrument team test data obtained over the past year has revealed degradation of pixel operability impacting several of the 5 and 2.5 micron cut-off detectors. There is a strong concern that the degradation will continue with time and many of the flight arrays will be out of specification by the time of launch. The key detector degradation observed was an order of magnitude increase in the dark count rate of individual pixels to levels in the range of 0.1 to 60 electrons per pixel per second ($e^-/\text{pix}/\text{sec}$). Figure 1 shows an example of this increase in dark count rate for one pixel in a flight spare NIRSpec detector (S060). Other performance anomalies were also observed and are listed in Table 2 at the end of this summary.

Figure 1. Example of increase in dark count rate for one pixel of a degraded detector. The blue data is for a good pixel and the red data is for the same pixel that has degraded with time.

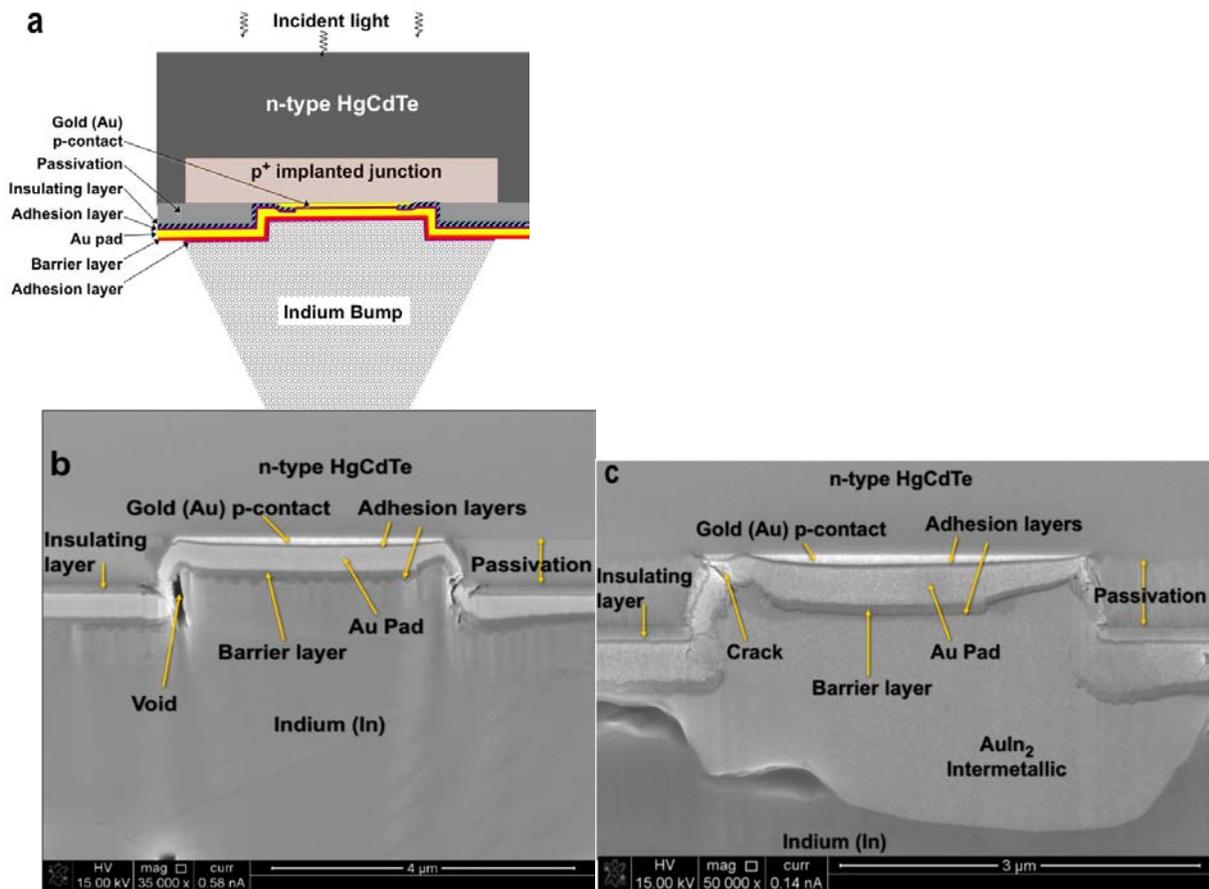
The DD-FRB finds that the detector degradation is caused by a **design flaw in the barrier layer** of the pixel interconnect structure. The flawed barrier layer design makes the detectors vulnerable to migration of indium from the indium bump interconnect into the detector structure, degrading its performance.

Figure 2a shows a cross-section of the pixel contact structure design. In this sensor design, each HgCdTe pixel is connected via the In bump to a source-follower amplifier in a silicon Read-Out Integrated Circuit (ROIC). The critically important barrier layer is intended to prevent In bump material from reacting with the Au pad and Au contact material such that it can not diffuse into the HgCdTe detector material. Figures 2b and 2c show cross-sectional micrographs obtained with SEM of a non-degraded pixel from a 2.5 micron NIRCcam detector array (C105) and a degraded pixel from a 5 micron NIRCcam detector array (C094). The cross-section of the pixel structure was generated by destructive physical analysis (DPA) using a focused ion beam (FIB) to cut through a line of pixels in the array. Figure 2c shows the formation of an AuIn₂ intermetallic as well as a crack in the left corner of the pixel contact structure propagating into the HgCdTe detector. The

intermetallic expands upon formation and most likely created a pocket of stress in the pixel.

Figure 2. a) Pixel contact structure; b) Scanning Electron Microscope (SEM) image of a non-degraded pixel in NIRCcam detector C105; c) SEM of degraded pixel in NIRCcam detector C094

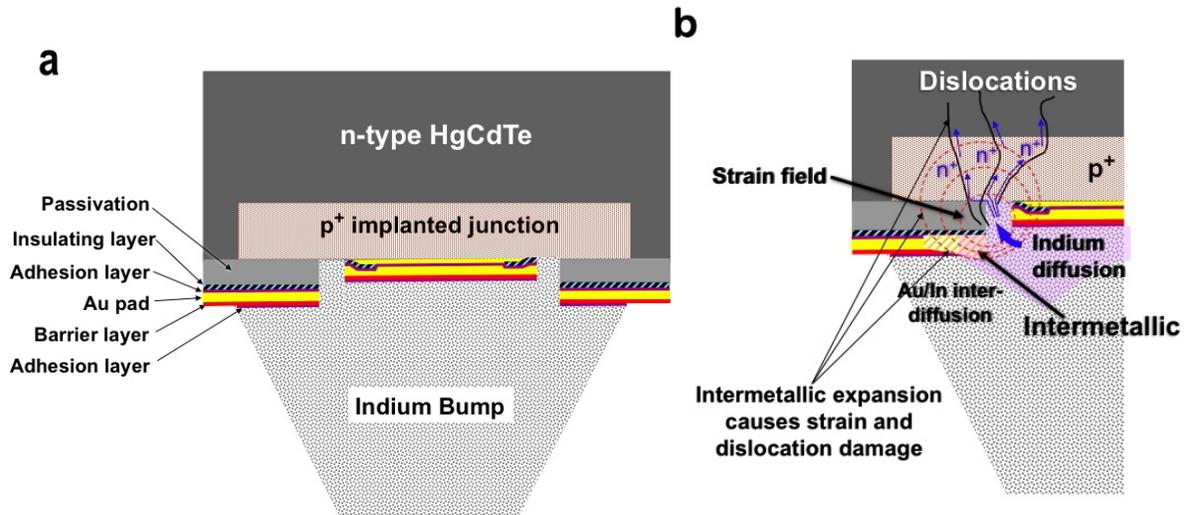
Figure 3(a) shows a diagram depicting failure of the barrier layer. Poor sidewall coverage of the layers over the step of the passivation layer or porosity of the barrier layer can allow In to inter-diffuse with the Au contact and Au pad metals to create In-Au intermetallics. Figure 3(b) illustrates some potential degradation mechanisms; the intermetallic expansion may cause strain and lattice dislocation damage to the HgCdTe and/or enable In to diffuse into the p⁺ HgCdTe of the implanted junction layer. Apart from production of charge traps in the semiconductor band gap, dislocation damage can also allow In or Au to diffuse more rapidly into the HgCdTe resulting in a dark current performance degradation rate that can be non-linear and difficult to reliably estimate.

Figure 3. (a) Inadequate barrier layer coverage; (b) Potential degradation mechanisms

Summary findings for charter items (b-d) above are in progress. At this juncture, the DD-FRB believes that a specific and practical method for fabrication of a fully effective barrier layer is available at Teledyne Imaging Sensors to eliminate the above design flaw in newly manufactured detectors. This design was developed for a higher background application than space astrophysics, and further testing is required to show that it can meet JWST performance requirements. The Board anticipates recommendation of screening and accelerated life tests to verify the long-term effectiveness of this solution. Finally, the Board anticipates recommendation of specific tests to assess the flight worthiness of JWST HgCdTe detectors that do not currently exhibit out-of-spec performance.

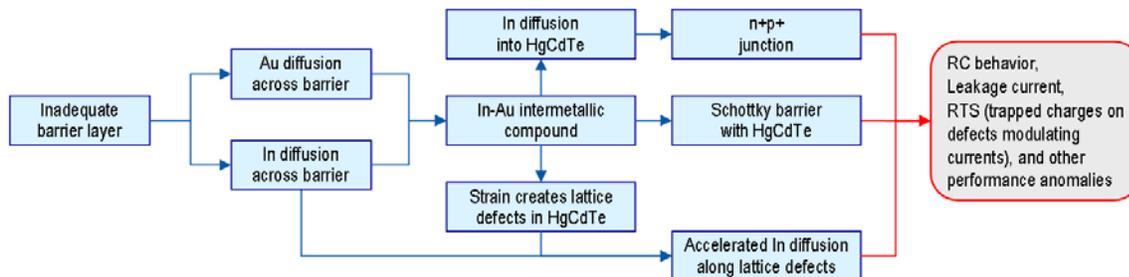
Figure 4. Degradation process in a pixel due to inadequate barrier layer

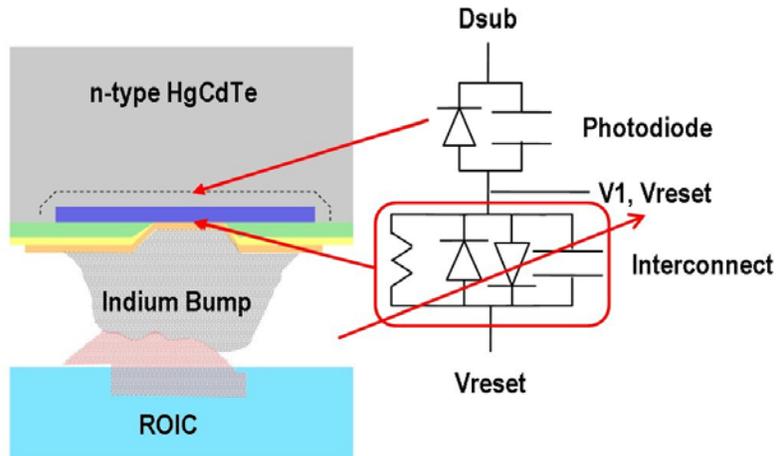
A degraded detector pixel can be modeled by an electrical circuit, which produces an integration ramp signal with an “RC”-like curvature early in the ramp (see Fig. 1). More extensive damage or indium diffusion will produce additional leakage currents through the photodiode. Although this circuit model approximately captures the essential behavior of degraded pixels (an “RC” at early times and leakage at later times), the actual circuit elements are far from ideal.

Figure 5. This electrical circuit model of a degraded pixel accounts for the “RC”-like curvature of dark ramps (see Fig. 1). The red-highlighted components form in the HgCdTe immediately above the failed barrier layer. These cause the “RC”-like shape. This simple model does not attempt to explain the degradation in the photodiode that causes enhanced leakage current.

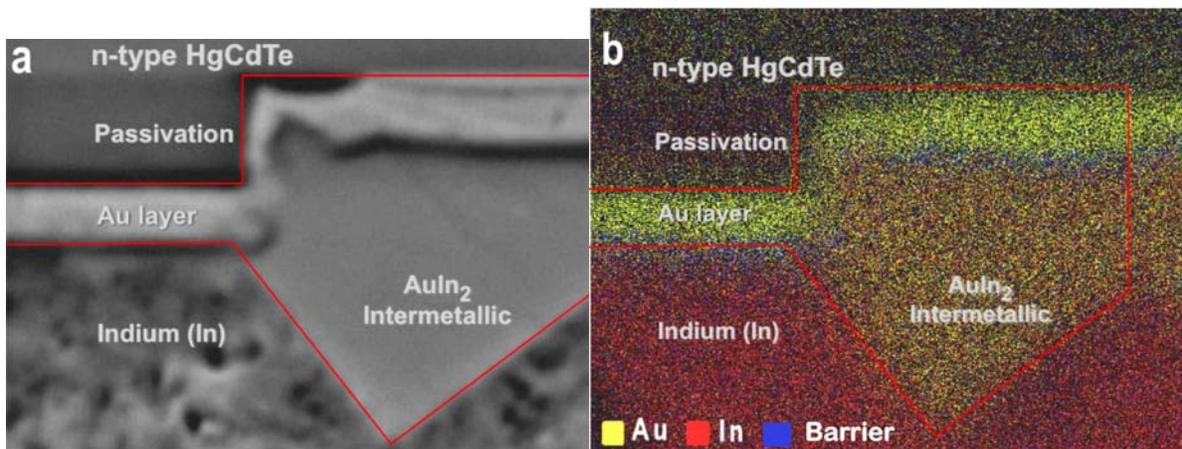
Formation of the In-Au intermetallic was confirmed by Energy Dispersive x-ray Spectroscopy (EDS) to provide a direct measure of the elemental composition. Figure 6a shows a SEM image of a corner of another detector pixel in detector array C094 with a corresponding elemental map for Au, In, and the barrier layer in Figure 6b. For these samples, the cross-section was prepared by cutting through the sample with a wire saw followed by mechanical polishing. The data show the formation of the In-Au intermetallic with a break in the barrier layer at the sidewall of the contact opening.

Figure 6. a) SEM of a pixel corner in NIRCcam detector C094; b) X-ray elemental analysis (EDS) of the same area showing that Au and In have interdiffused to form an intermetallic compound ($AuIn_2$) due to failure of the barrier layer

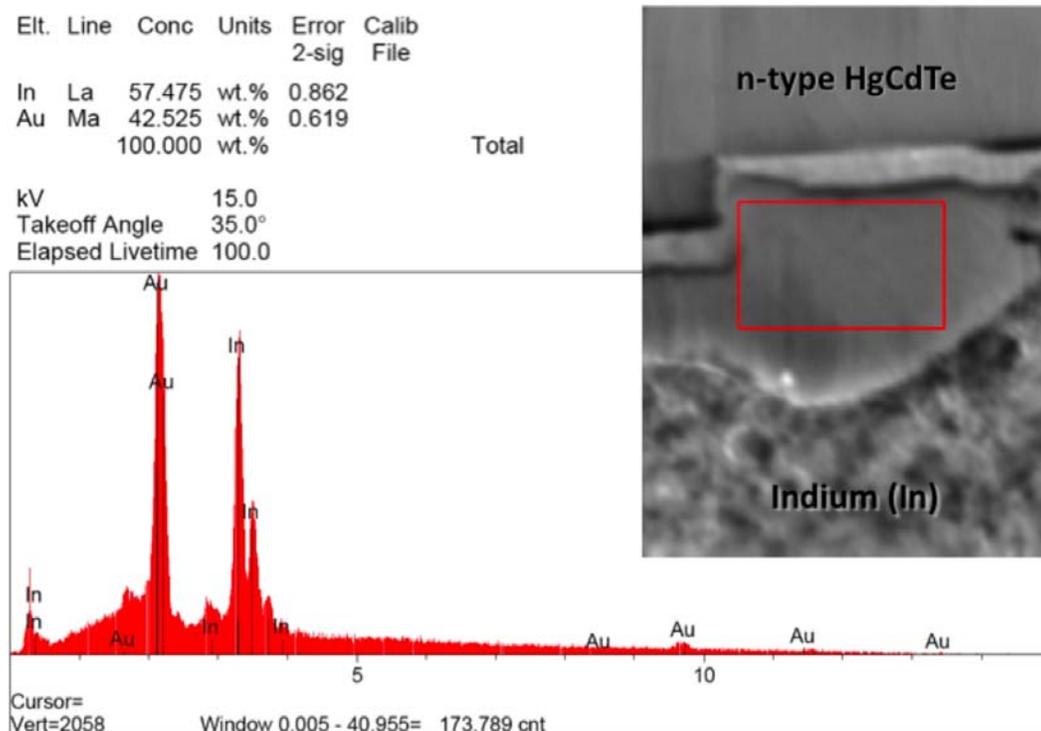
Additional EDS data was taken on another pixel in detector C094 as well as the Process Evaluation Chip (PEC) for C094. Figure 7a shows the SEM and the x-ray analysis area (red box) from the PEC and Figure 7b shows the x-ray spectrum. Quantitative analysis of the weight percentage of the volume measured shows that the In-Au compound is AuIn_2 .

Figure 7. a) X-ray analysis (EDS) of red box area in SEM image demonstrates the formation of an In-Au intermetallic (AuIn_2)

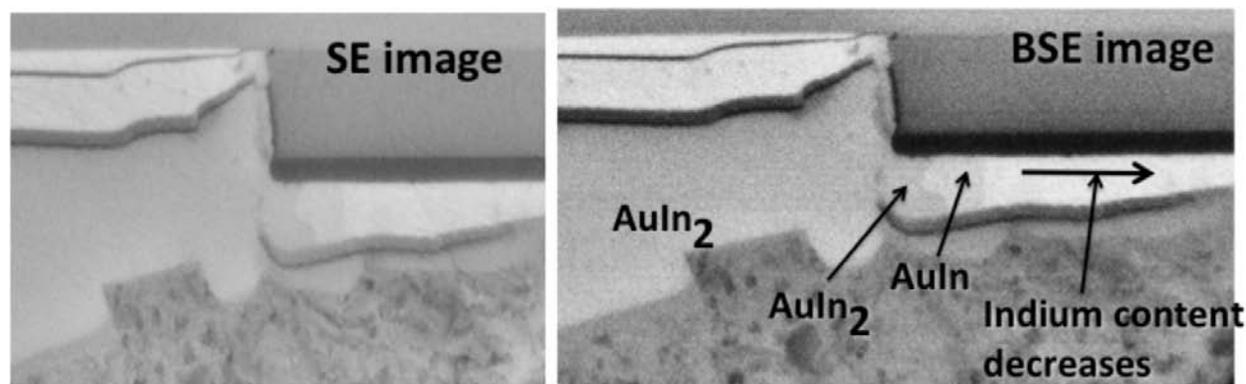
Figure 8 shows a SEM image and a backscatter electron image of a cross-section of a pixel in detector array C094. Combined with EDS analysis on the different regions, the results show that there is interdiffusion of both In and Au past the barrier layer with the formation of AuIn_2 and AuIn intermetallics that expand in volume.

Figure 8: SEM and Backscatter Secondary Electron (BSE) image of detector pixel in C094
