Completion of the JWST Spacecraft/Sunshield and Telescope/Instrument Elements

Randy A. Kimble¹, Charles W. Bowers¹, Michael W. McElwain¹, Malcolm B. Niedner¹, Erin C. Smith¹, and the JWST Project Team

¹NASA Goddard Space Flight Center

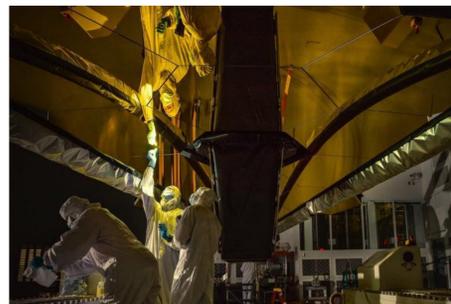
Brush cleaning of the JWST primary mirror

In April 2019, the primary mirror segments were carefully cleaned with a light-contact brush technique. This cleaning was very effective and essentially reset the clock with respect to particulate accumulation. The secondary mirror, which remains accessible late in the flow, will be cleaned shortly before shipment to the launch site. Current projections indicate that the payload will comfortably meet its contamination requirements at the time of shipping.

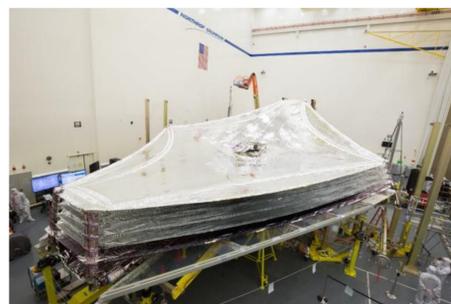
Deployed, tensioned sunshield

Prior to the Spacecraft Element environmental test program, deployment testing of the five-layer sunshield was accomplished. Enhancements to the Membrane Tensioning System to improve its reliability were identified, which have since been implemented successfully.

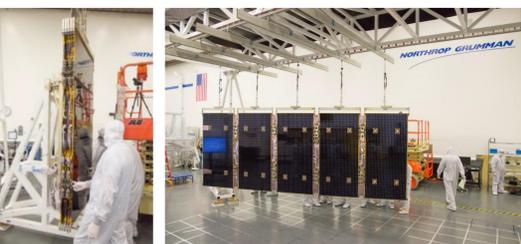
Solar Array Deployment Testing – Panel Unfolding

The solar array, for example, was tested for release of the launch restraint devices while mounted to the spacecraft; however, for proper unfolding of the five panels, a specialized gantry system was used to provide gravitational offloading.

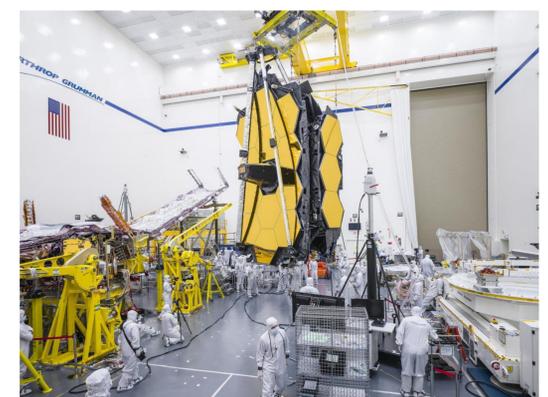
The Two Final Pieces of JWST Came Together in August 2019

After the successful completion of the Spacecraft Element functional and environmental test program, the two final pieces of the Observatory were ready for mating, which was initiated in August 2019. See poster 372.09 (McElwain et al.) for a report on the Observatory-level integration and test program, which is now well underway.

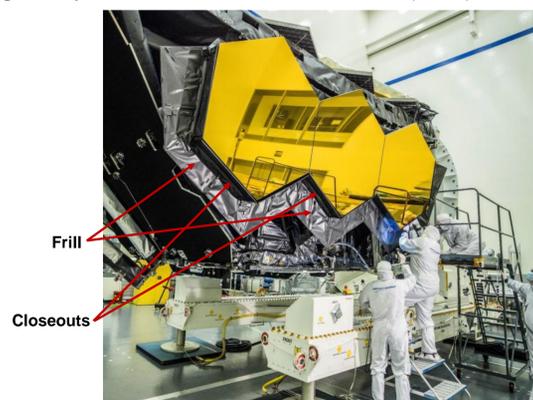
Frill/closeout repair at Northrop Grumman

One of the few technical issues identified in the OTIS cryo-vacuum test was that the frill/closeout assembly surrounding the primary mirror (pictured above) had insufficient slack and exerted unwanted forces on the mirror backplane at operating temperature. This introduced the potential for wavefront instability with temperature variations in flight. One of the key activities after delivery of OTIS to Northrop Grumman was to carefully rework this assembly to restore the intended slack, mitigating the concern for flight.
